**ADDENDUM NO. 2
TO
CONTRACT DOCUMENTS
FOR
655 COOK AVENUE**

DATE: November 1, 2013

This document has been assembled to aid Contractors in preparing their bids for this Project. The present condition of the property is one of mid-construction. Assessment has been taken of the work completed and recommendations are made as to; acceptance of the Work, unfinished Work, rejection of the Work, and Work to be completed. Photographs have been included, in each specification section where appropriate, to provide additional clarification.

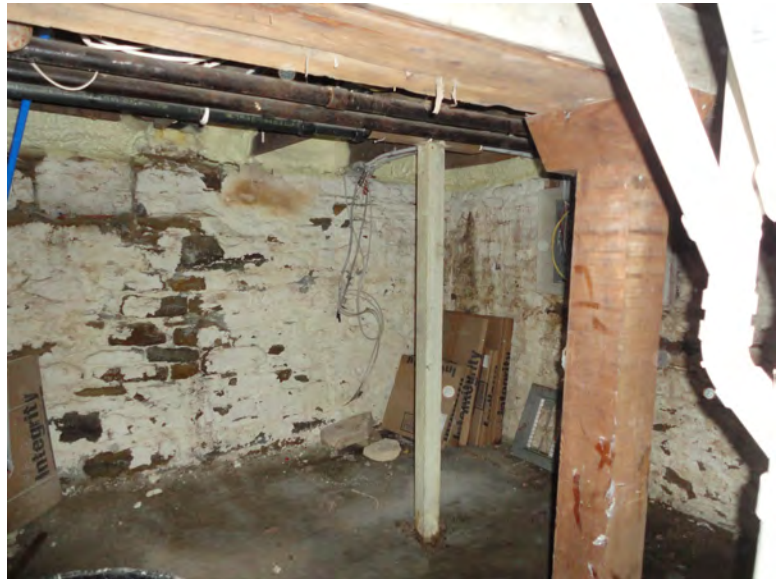
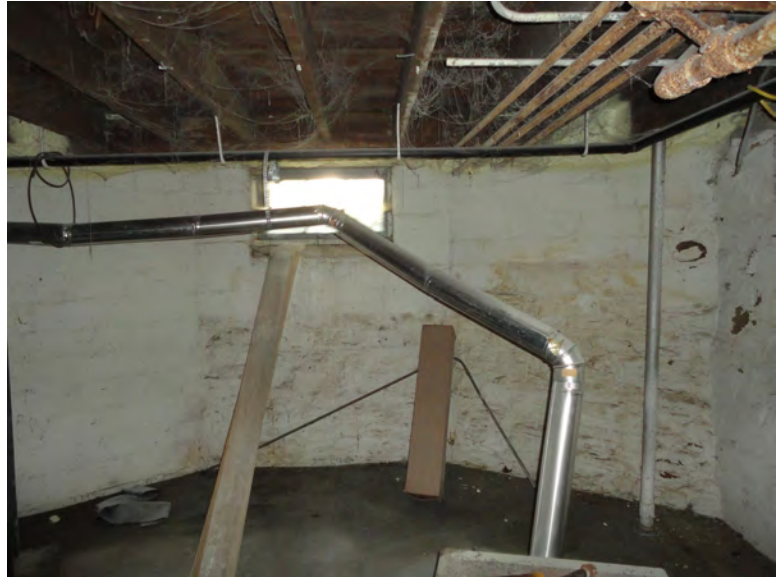
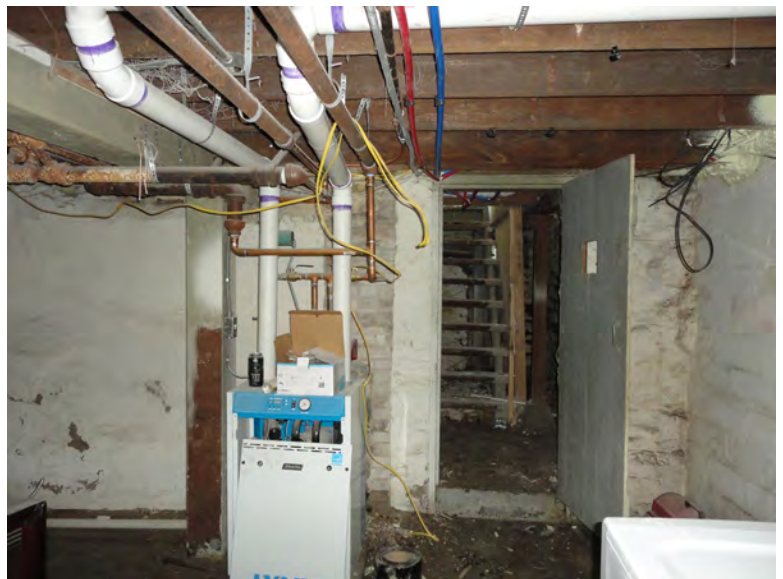
This work has not been completed

Condition of Basement Floor and Walls

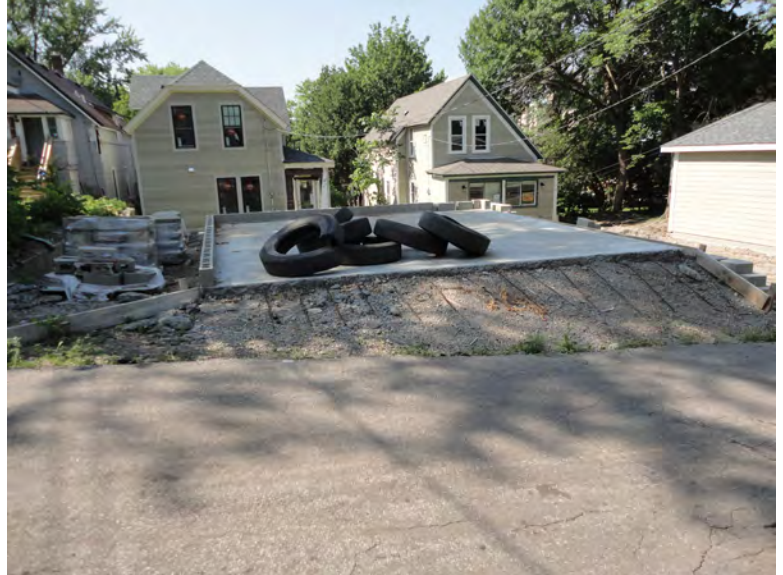
1. 10" thick x 20" wide, continuous.
 - a. Detached garage frost footing. - existing garage slab to be removed and replaced
 - b. Step frost footings at top and bottom of steps. - verify, probably not done
2. 8" dia. x 5'-0" deep piers at fence and handrails. - not started

Garage slab to be removed

1. We recommend the stack block retaining walls on the property be rebuilt with the proper tie-back system per the manufacturer's recommendations.
2. We recommend the existing new garage slab be removed because of the large cracking and settlements and steep pitch at the alley. The sub-base should be well compacted granular material to frost depth per IRC requirements for thickened edge garage buildings.

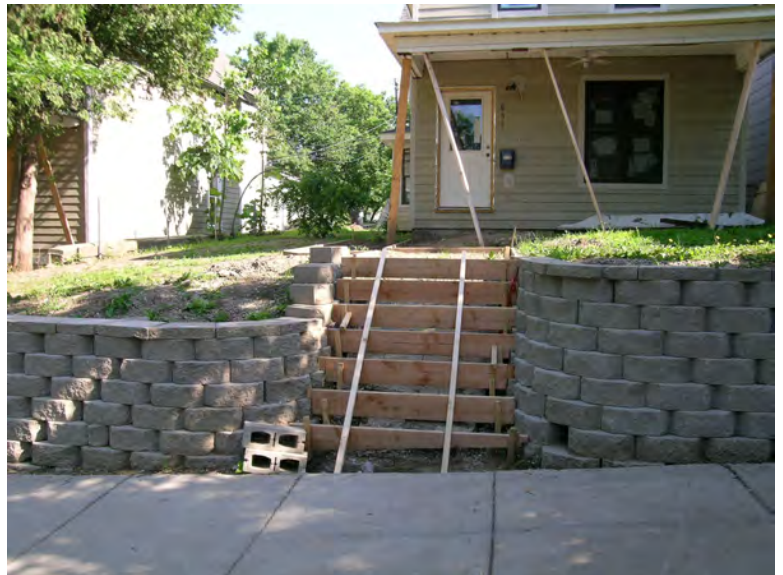
Work not completed at front or rear stairs

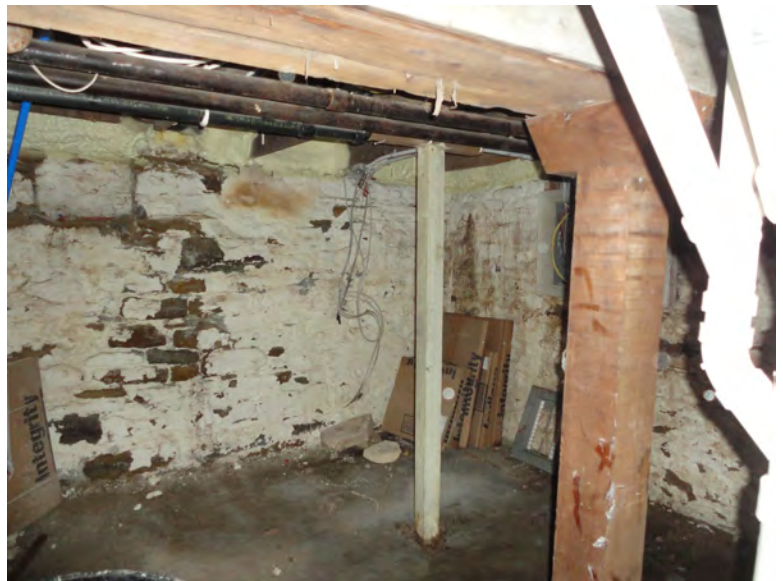
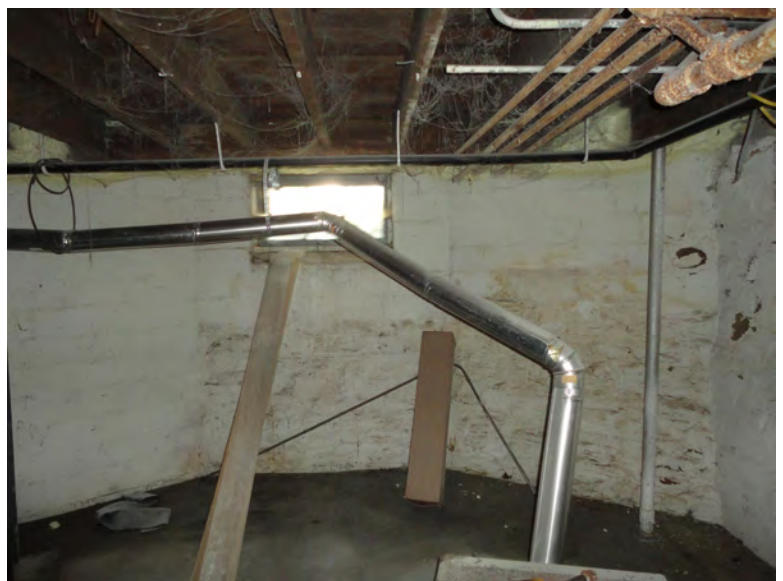
This work has not been completed:

Typical Basement conditions

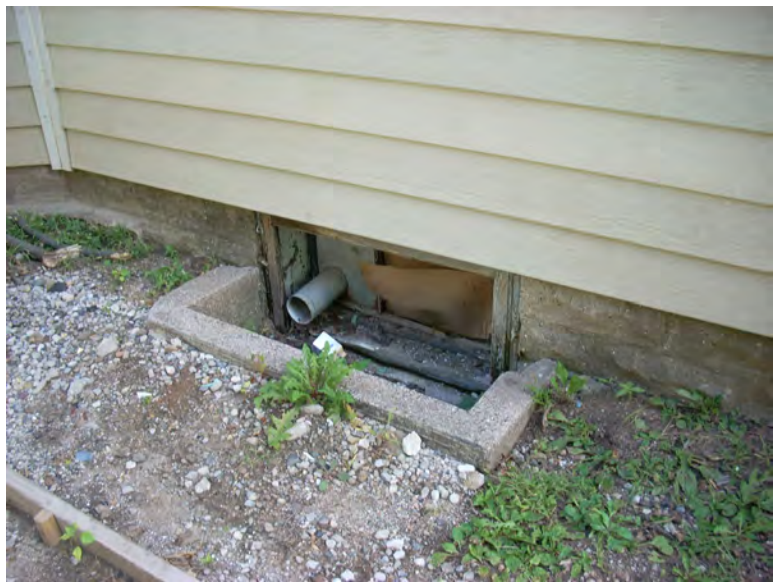
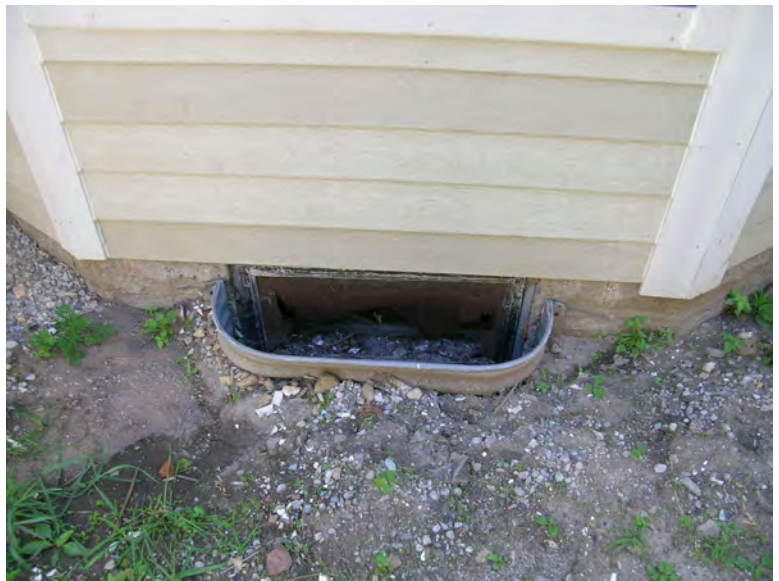
This work has not been completed:

Existing Basement windows

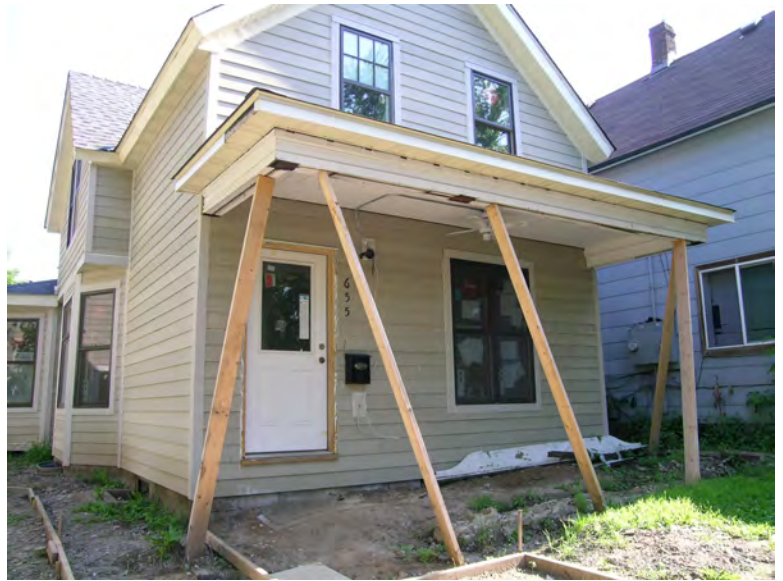
Existing Front Porch

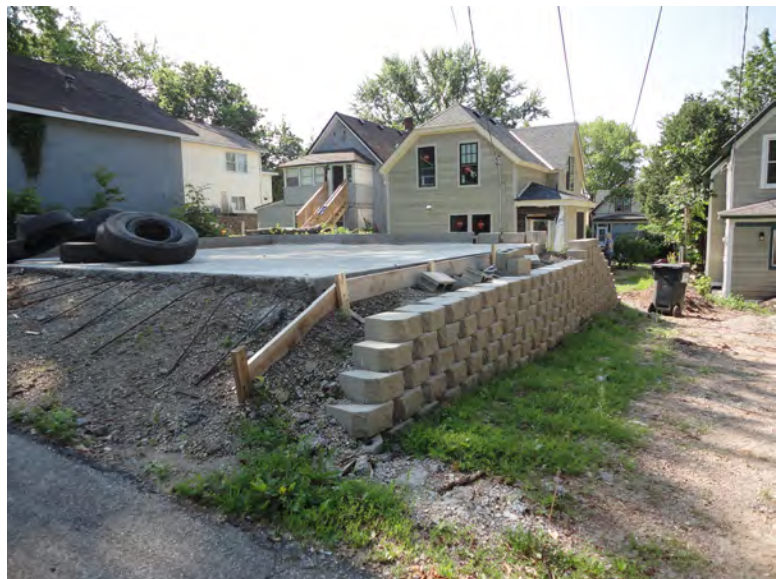
Garage not built

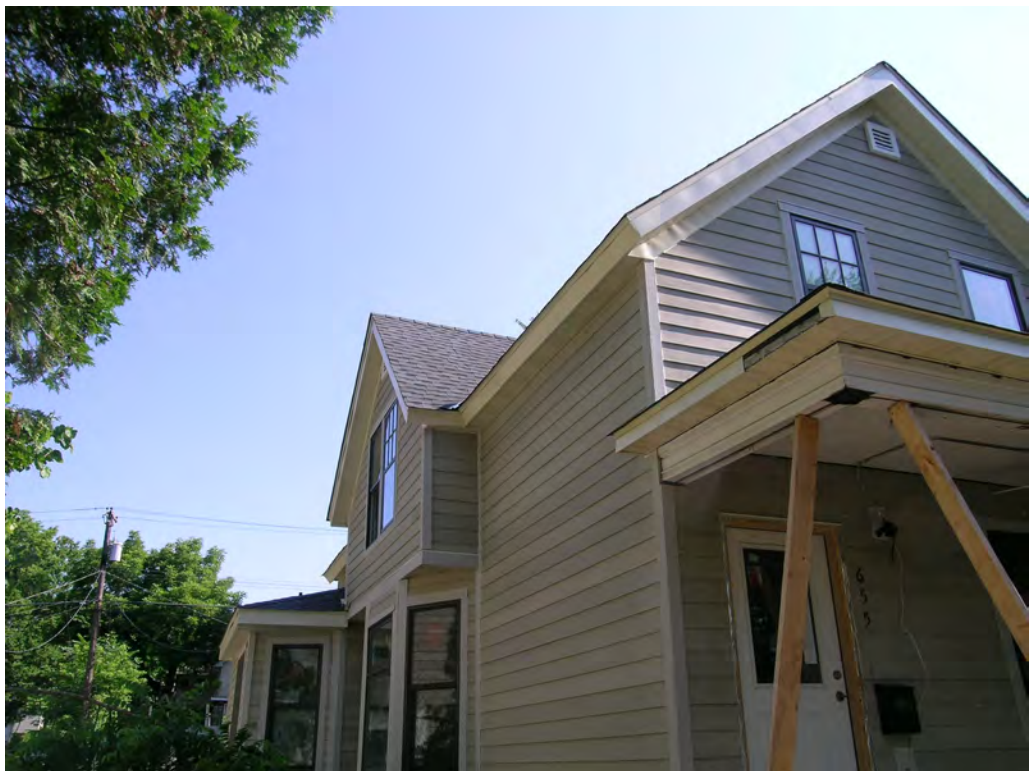
- A. House - no drip edge, roof vent is missing, and no ventilated soffits

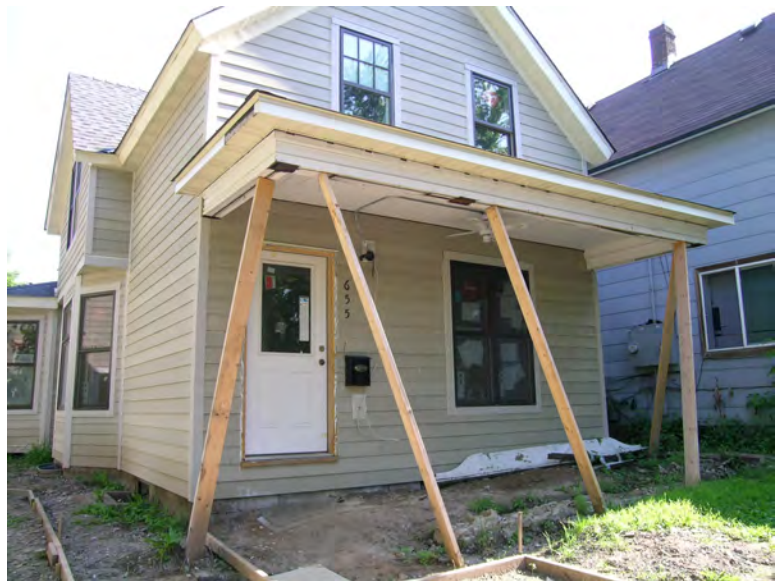
- B. House - perimeter detailing at foundation wall to be reviewed, bottom trim board is missing in places, siding at porch connection will need to be revised, and there is missing siding in various places
- C. New Garage - not yet started

Missing bottom trim and siding revision for porch connection

Note: Pull 10% siding off various points and check condition of sheathing and weather barrier. Remove and reinstall any uneven siding and trim.

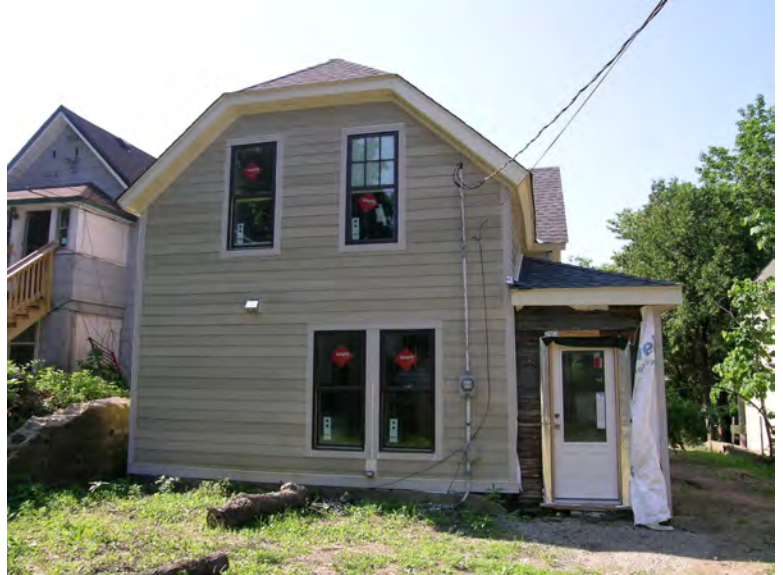
Missing siding

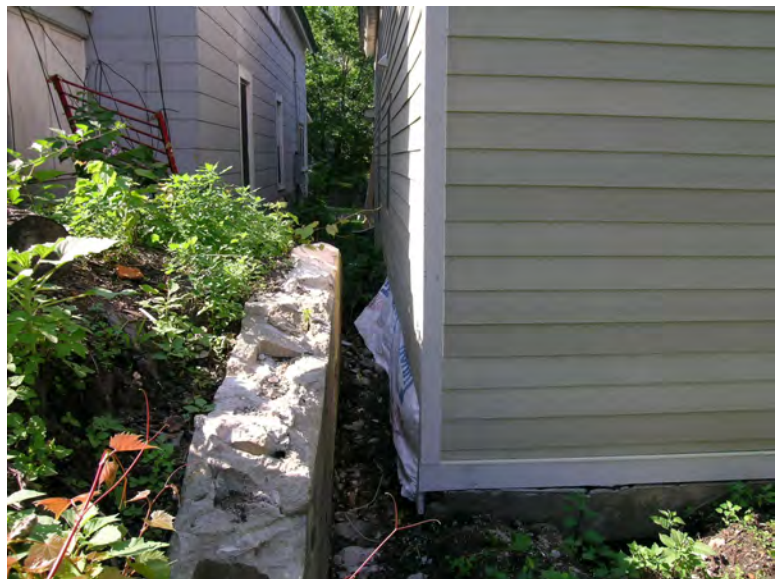
Missing siding

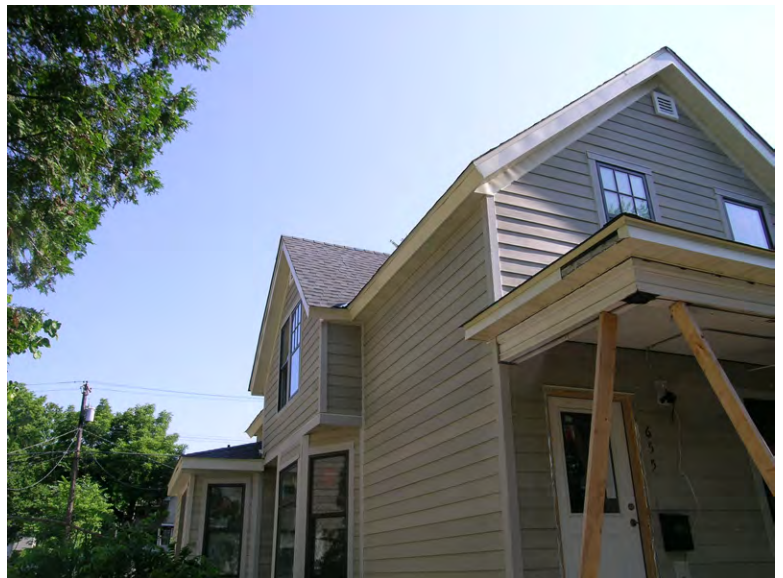
Gutters and downspouts have not been installed.

Typical roof eave

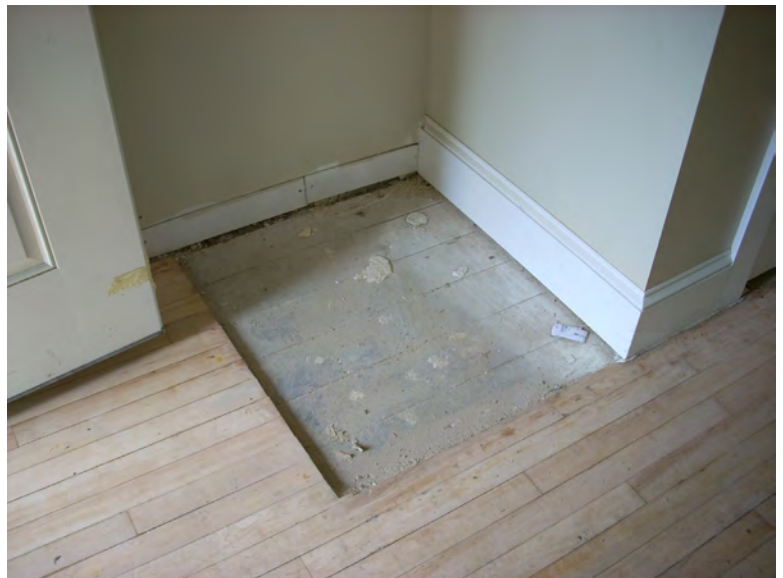
Floors are sanded but not finished. This work should be reviewed and suggestions may on how to proceed. Miscellaneous repairs are needed. Stair treads and risers need to be installed for both the Basement stairs and the stairs to the second floor. **Carpet has be put down on the stairs to second floor, and this should be removed.**

Floor repair - various locations

Note:: Use Kitchen flooring to patch and repair other wood flooring.

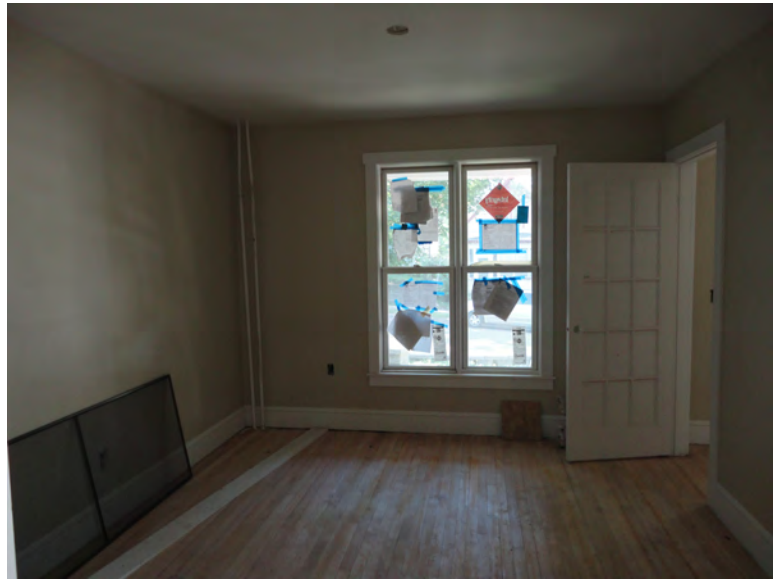
Living Room Floor

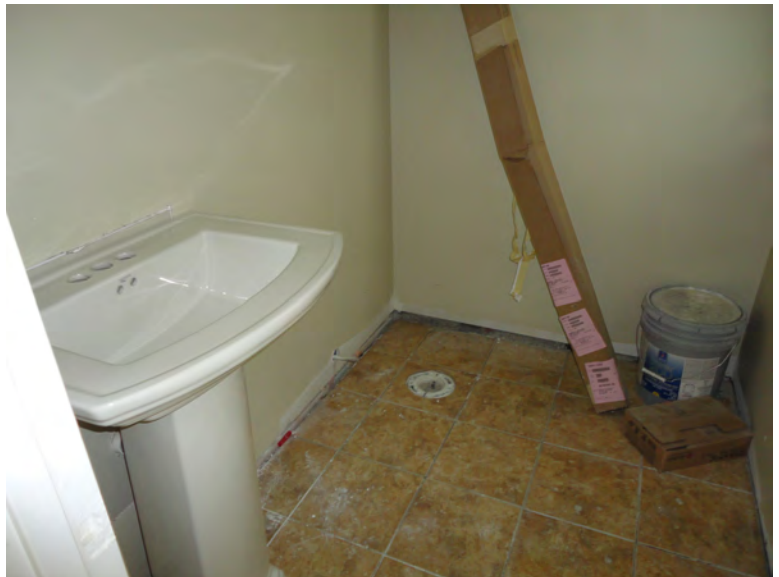
First Floor floor tiling

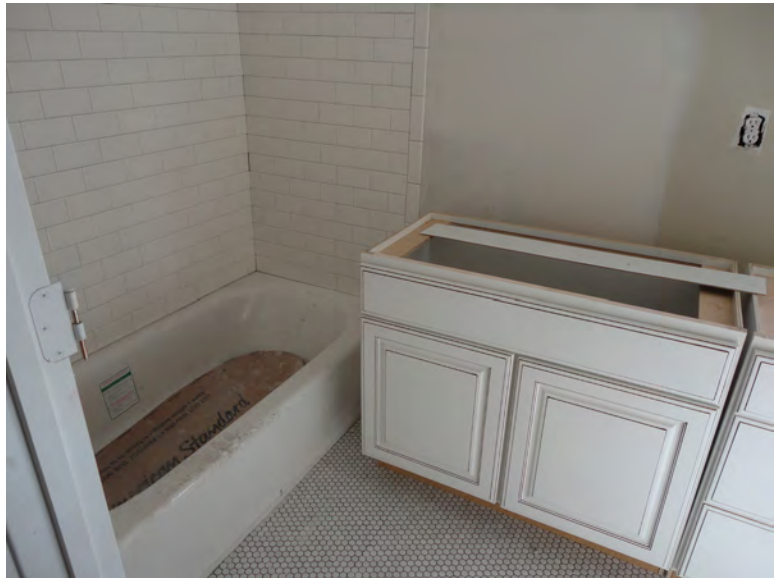
Second Floor tile surround

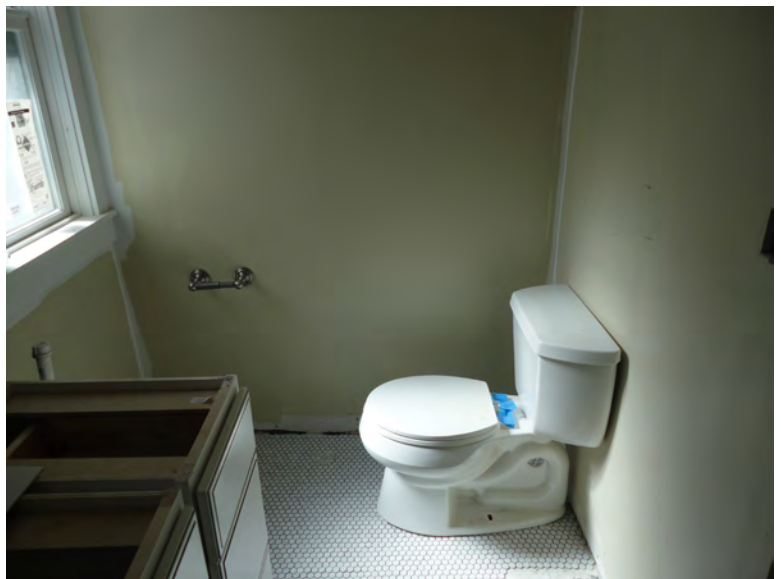
Second Floor floor tile

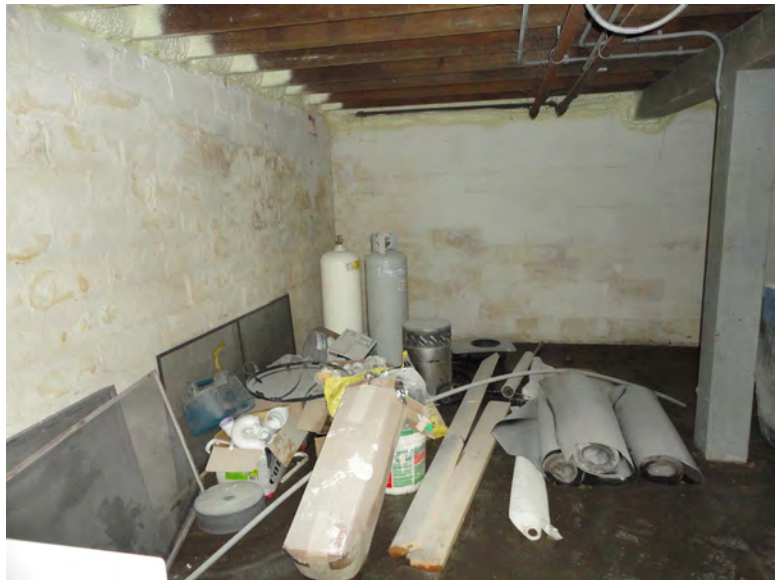
This work has not been completed.

Existing condition of Basement

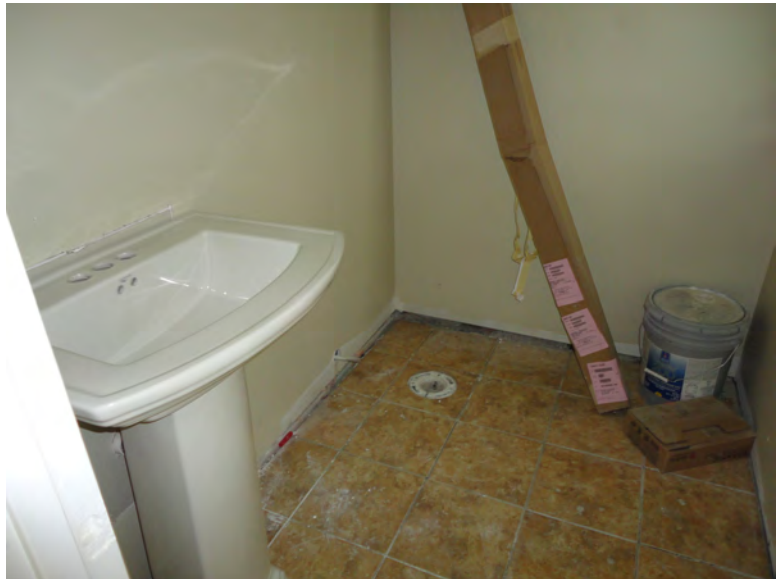
- A. First Floor powder room - **not installed**
- B. Second Floor bathroom - **not installed**

First Floor powder room

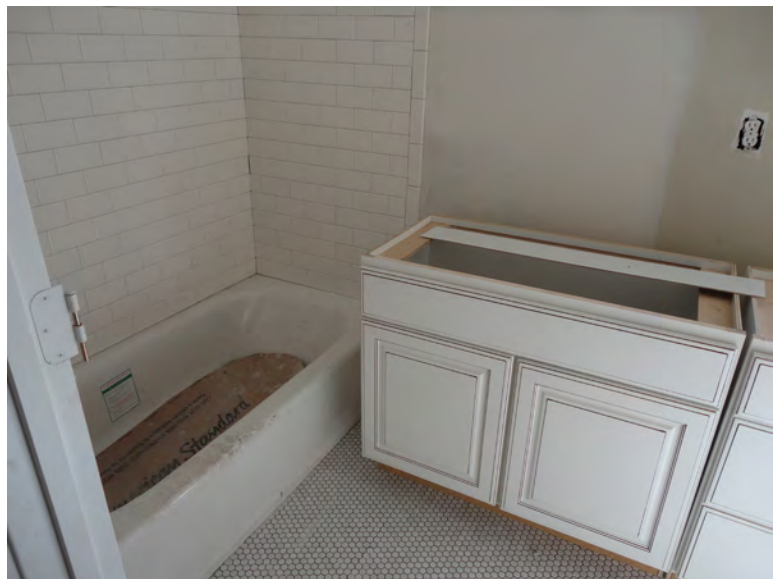
Second Floor Bathroom cabinets

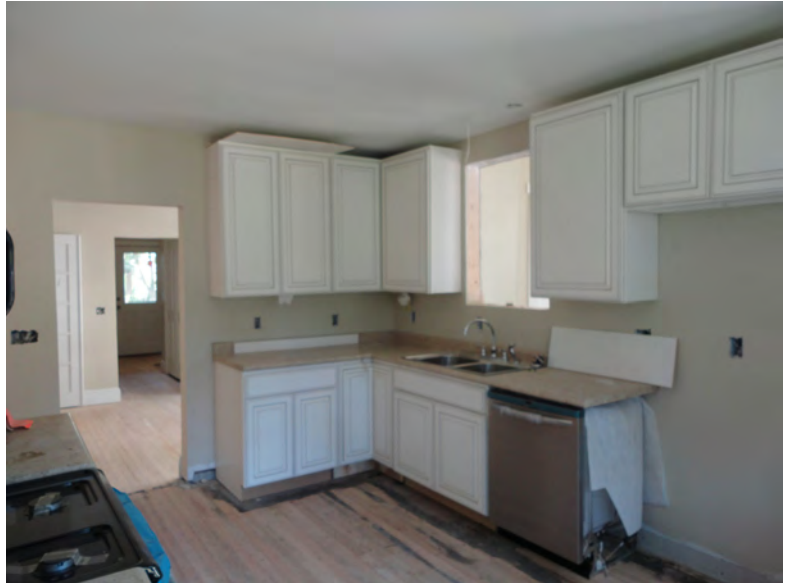
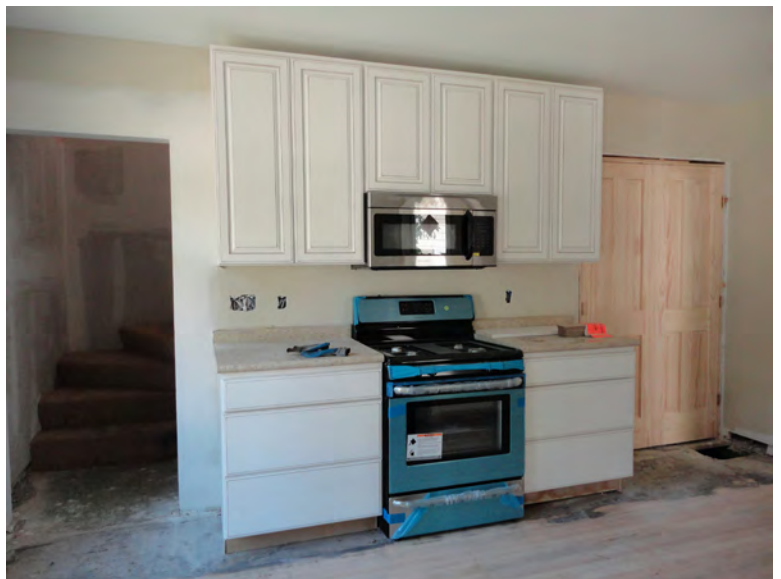
- A. Provide base and wall cabinets and plastic laminate countertops at Kitchen. Countertop installation to include side and back splashes - **mostly completed**
- B. Provide bath vanity cabinets at 2nd floor bath, including integral sink - **cabinets on-site, no sink or tops**
- C. Provide cabinet over toilet at second floor to match - **not on-site**
- D. Provide Closet Maid pantry cupboard with light at kitchen - **not completed**
 - 1. See attached for Closet Maid pantry system shopping list.

Existing Kitchen installation

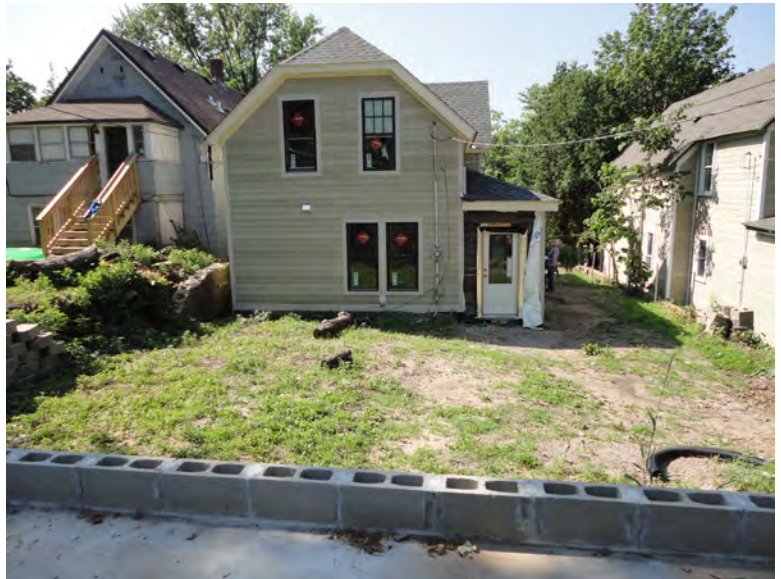
Grading is not completed

Existing rear yard condition

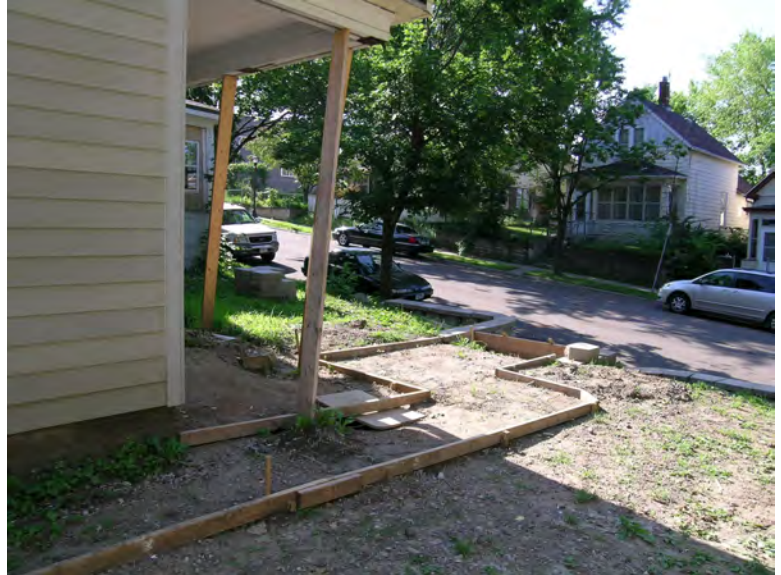
- A. See Landscape and Site Plans - **not done**
- B. Include 10" NDS Catch Basin installed in walkway as per Landscape Plan - **not installed**
- C. Install 4" Schedule 40 PVC pipe under concrete walkway connecting to catch basin as per Plan - **not installed**

Front entry sidewalk, missing catch basin

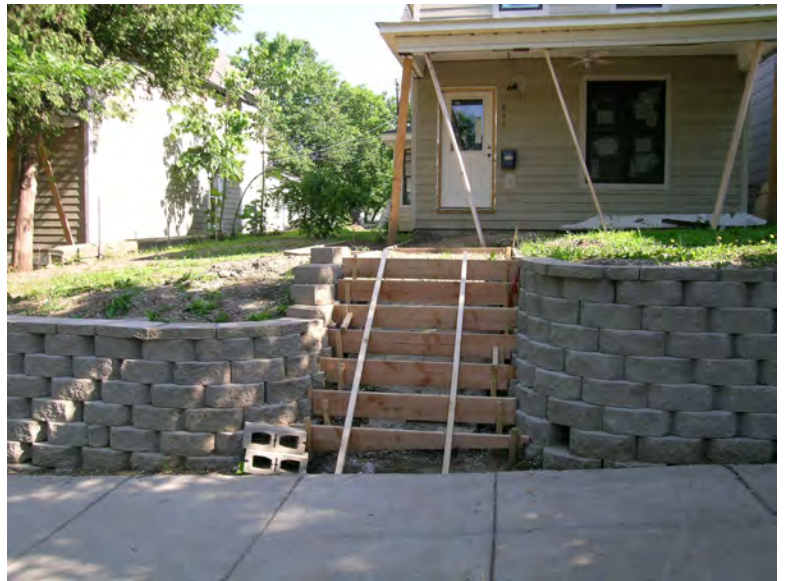
Existing front step framing

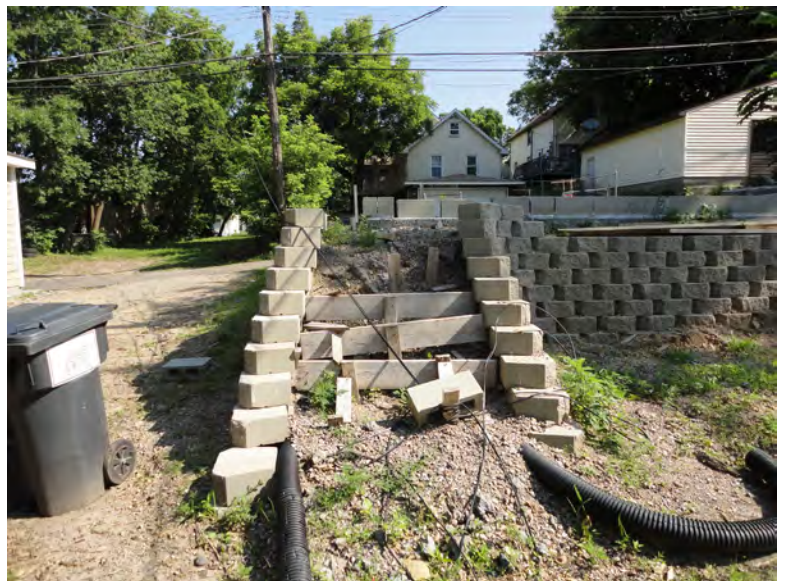
Existing rear step framing

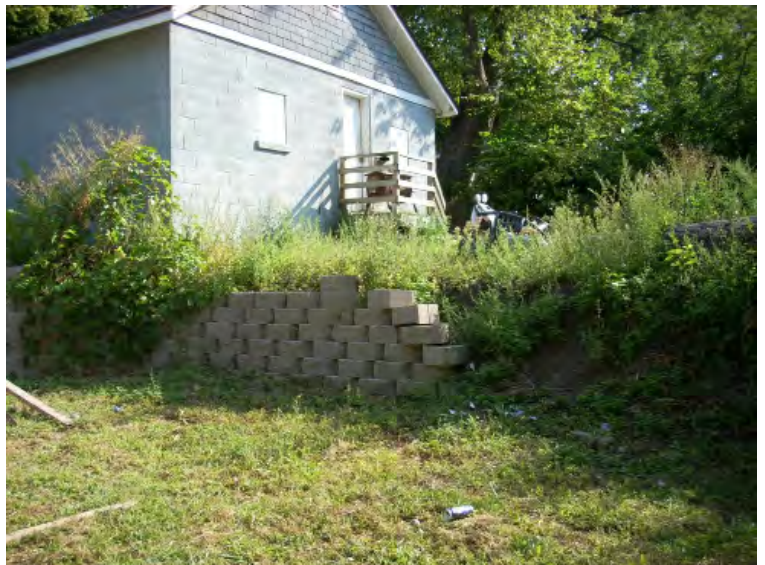
- A. Top of retaining wall: east lot line - **not installed**

Existing east retaining wall

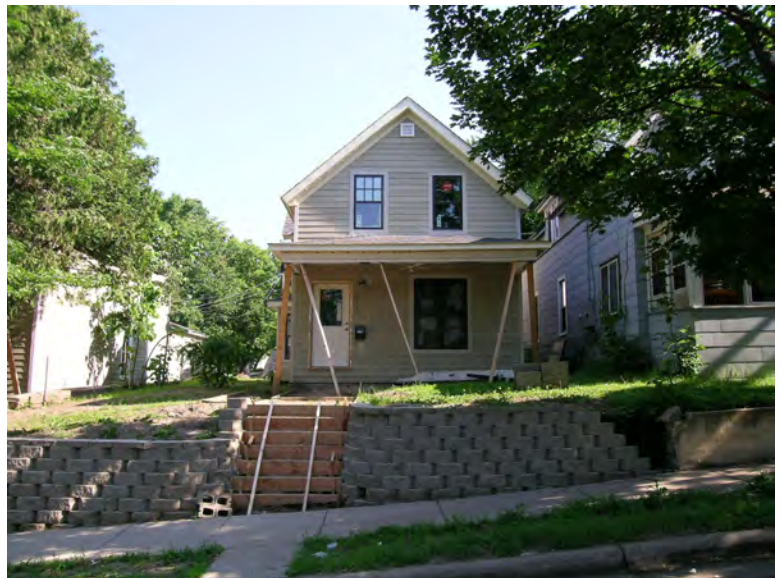
- A. **Partially installed - all walls will need to be reinstalled to meet manufacturers instructions.**

Partially installed front retaining wall

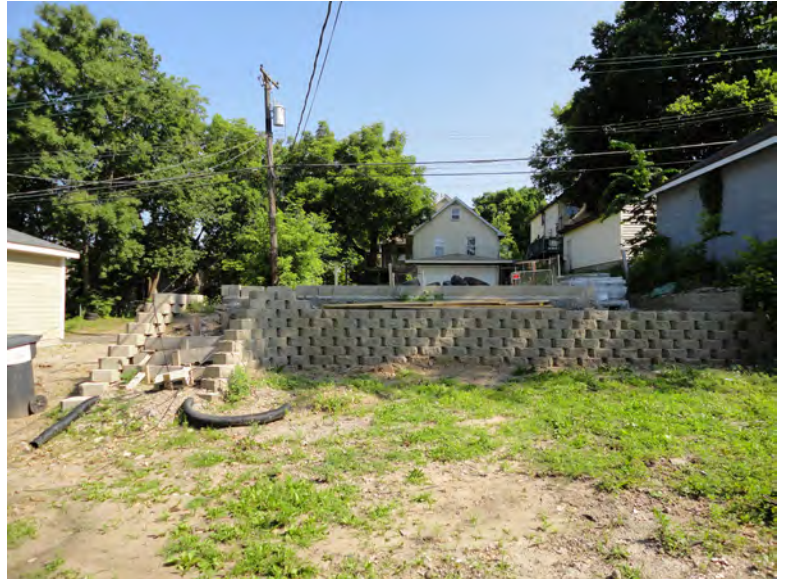
Rear retaining wall

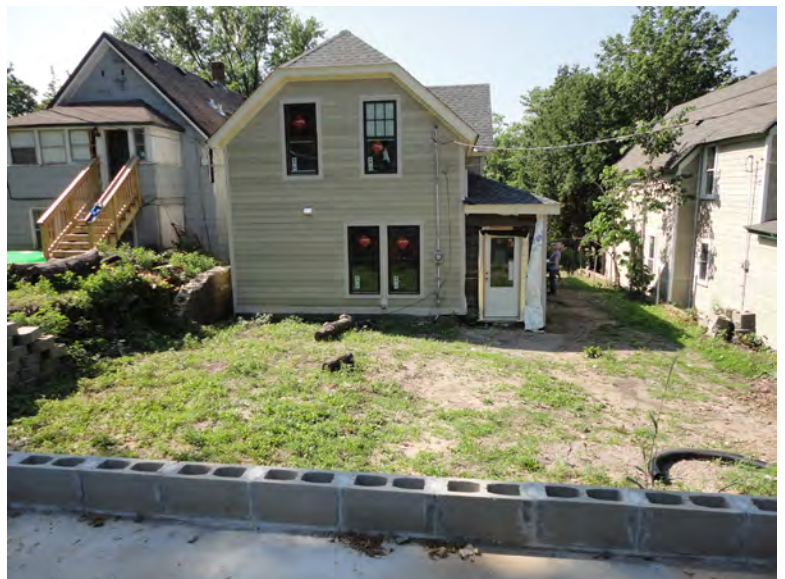
East retaining wall

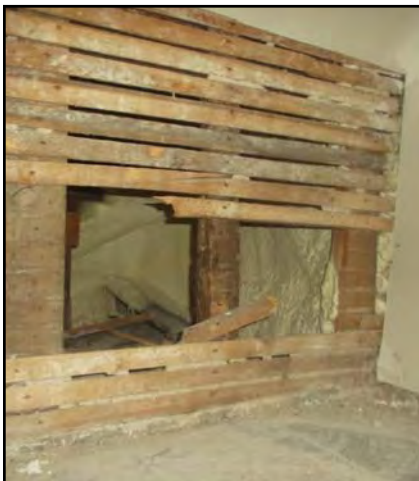
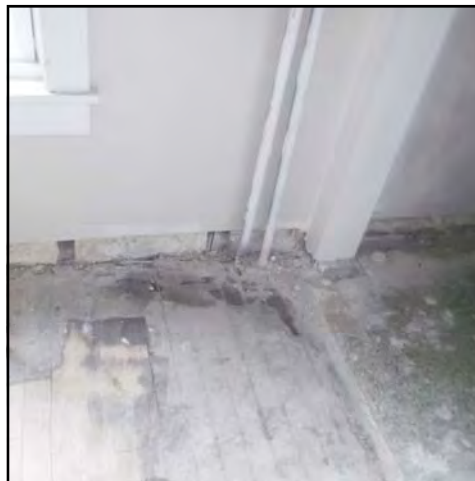
These two images show that the walls have been insulated with sprayed foam insulation.

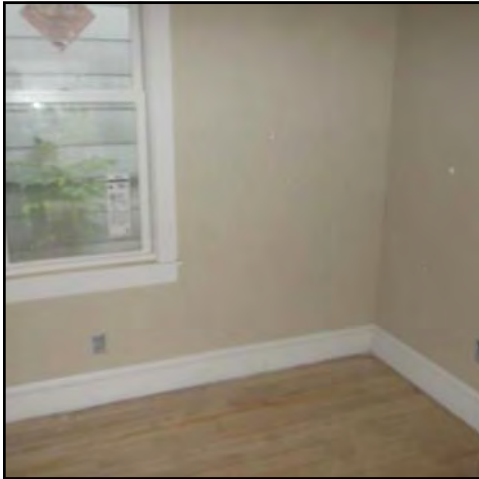
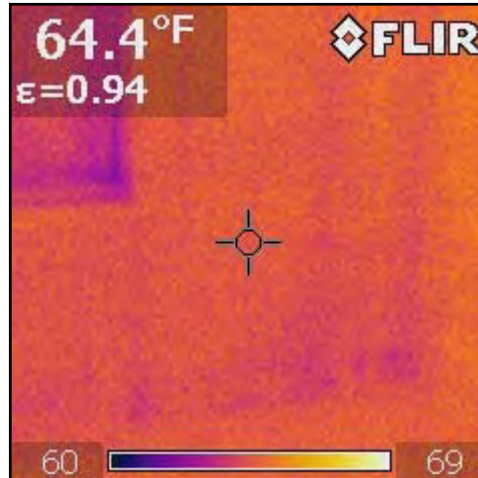
This image is representative of all the exterior walls. While the temperature differential was too small to conclusively say that the walls are fully insulated, this image does show that the studs are cooler than the cavities. This, plus the exposed part of the wall cavities seen on the first two images leads me to conclude that all the walls are insulated.

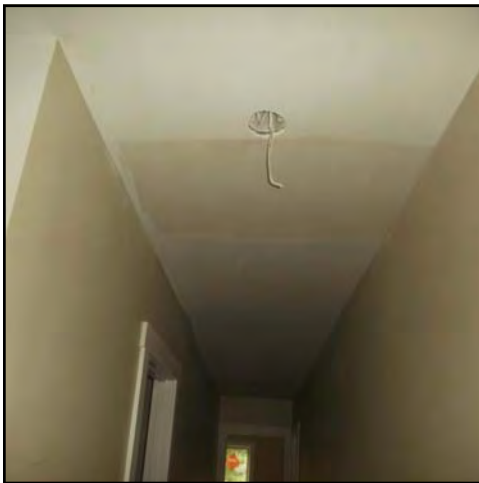
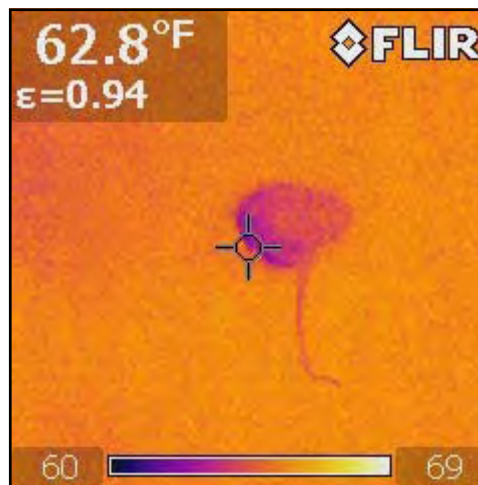
This image of the upstairs hallway shows some air infiltration around the electrical box during the blower door test. This is representative of all the ceiling electrical boxes and it is recommended that they be caulked before the ceiling fixtures are installed.

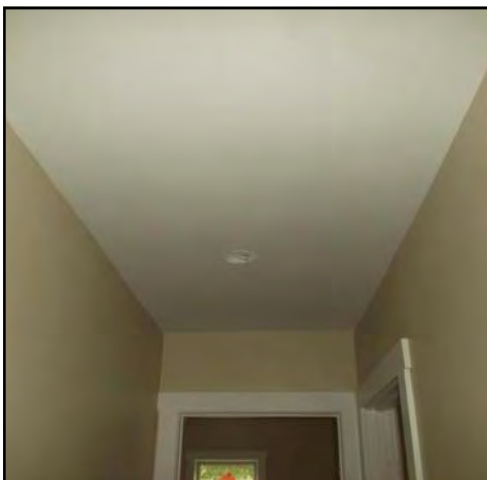
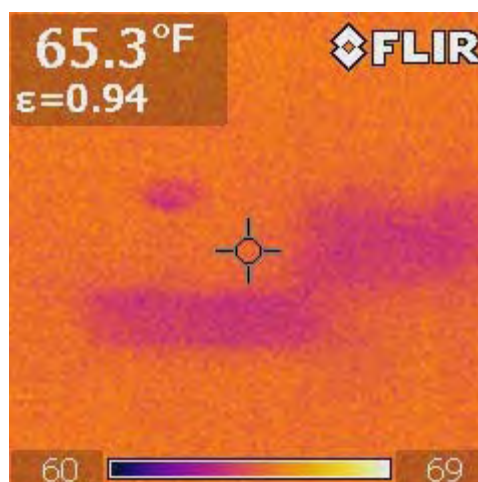
This and the next two infrared images of the second floor hallway and bathroom appear to indicate insulation voids in the attic. There is no access to the attic so these insulation voids could not be verified. The recommendation would be to cut a hole in each area to determine if these areas are small voids or bare areas of the attic floor.

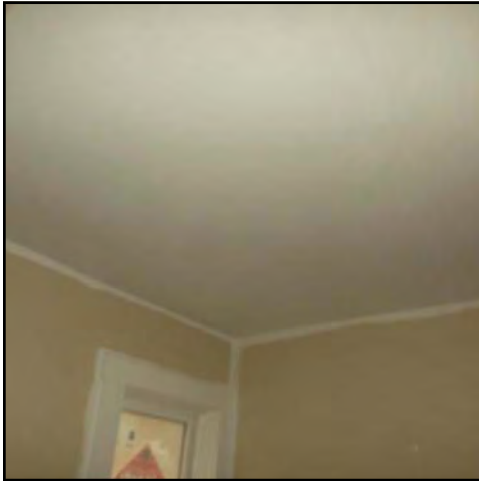
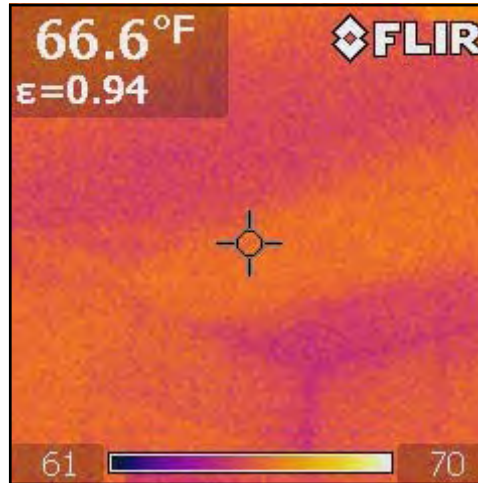
Second floor bathroom.

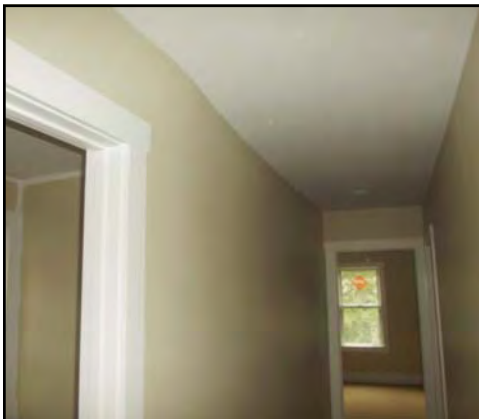
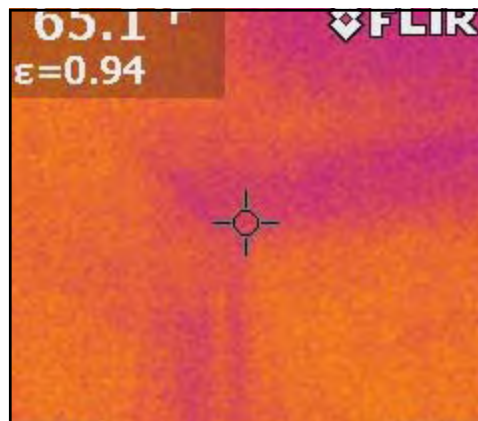
Hallway outside of bathroom.

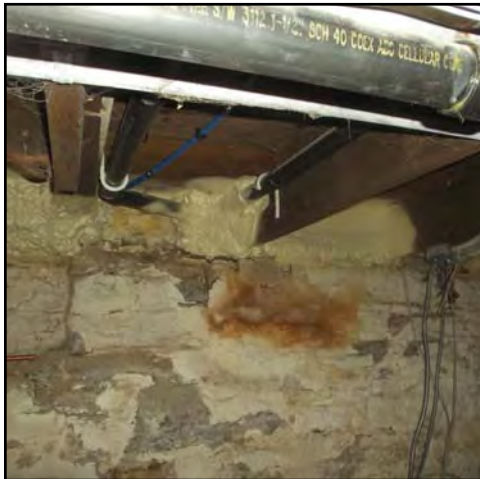
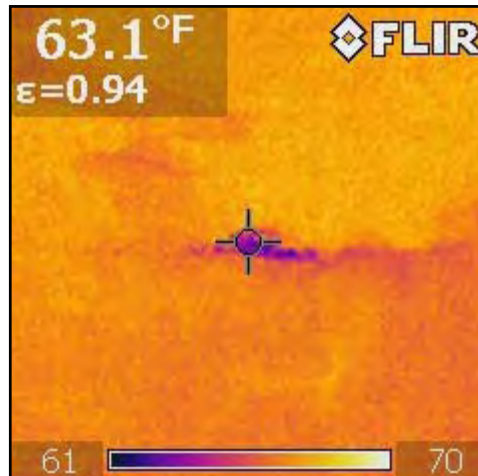
Air leakage in rim joist where the spray foam insulation has shrunk

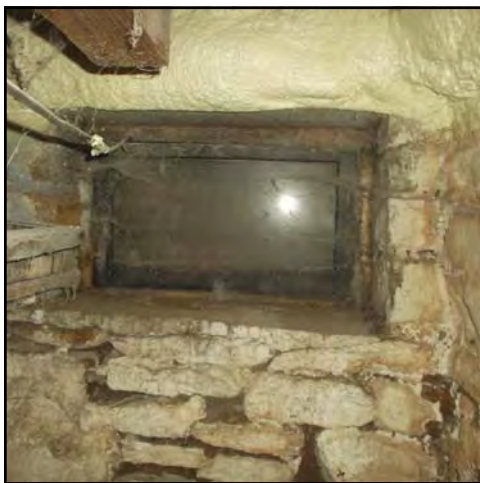
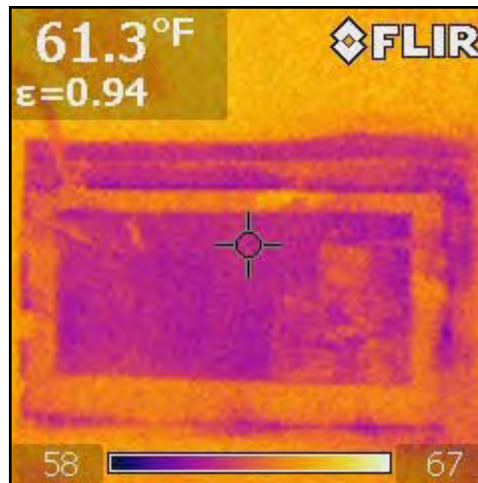
None of the basement windows have been replaced yet and are very leaky.

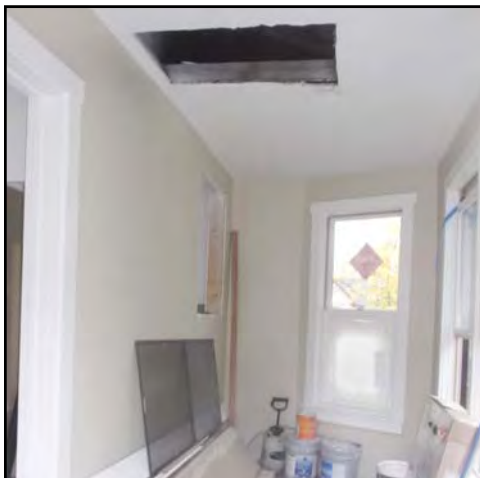
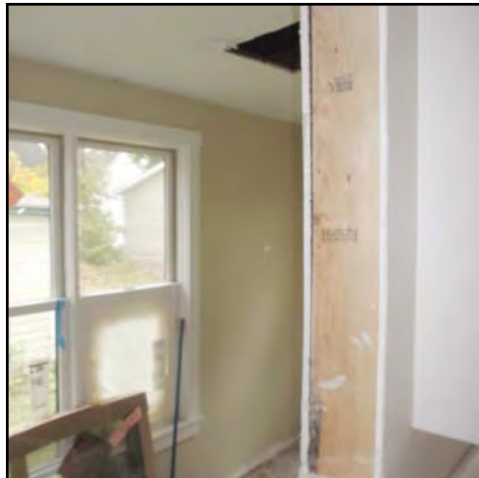
There is a back porch that, according to the floor plans in the kitchen, is being converted to a mudroom. The exterior walls have been insulated and finished and there are new windows. However, neither the attic above the mudroom nor the floor below has been insulated yet. An exterior inspection of the mudroom indicates that it is sitting on a concrete footing. Unfortunately, the top of the footing is almost level with the ground which would make insulating the floor extremely difficult. For these reasons, my recommendation would be to leave the mudroom as an unheated space, not insulate the ceiling or floor and install a window in the rough opening between the kitchen and the mudroom.

Mudroom with opening in wall where presumably a window will be installed and a missing access panel in ceiling.

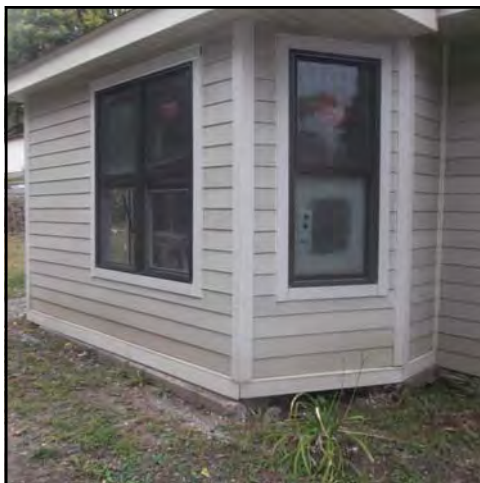
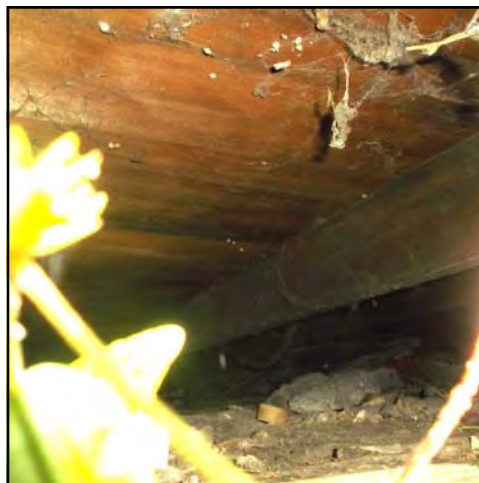
Mudroom floor that is not insulated.

ADD: Mudroom: pull up floor, level ground below, cover ground with 6 mil poly, seal closed cell foam insulation to poly, new rim joist.

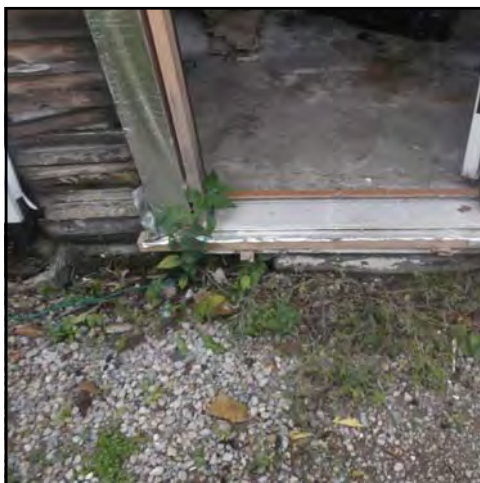
Exterior door of mudroom. Wood at base of wall looks like it needs to be repaired or replaced.
